**CONCEPTUAL DESIGN REPORT**

**TOWN PARCEL RETROFITS FOR**  
**STORMWATER QUALITY IMPROVEMENTS**

**TOWN OF PEMBROKE, NEW HAMPSHIRE**

**JUNE 2023**

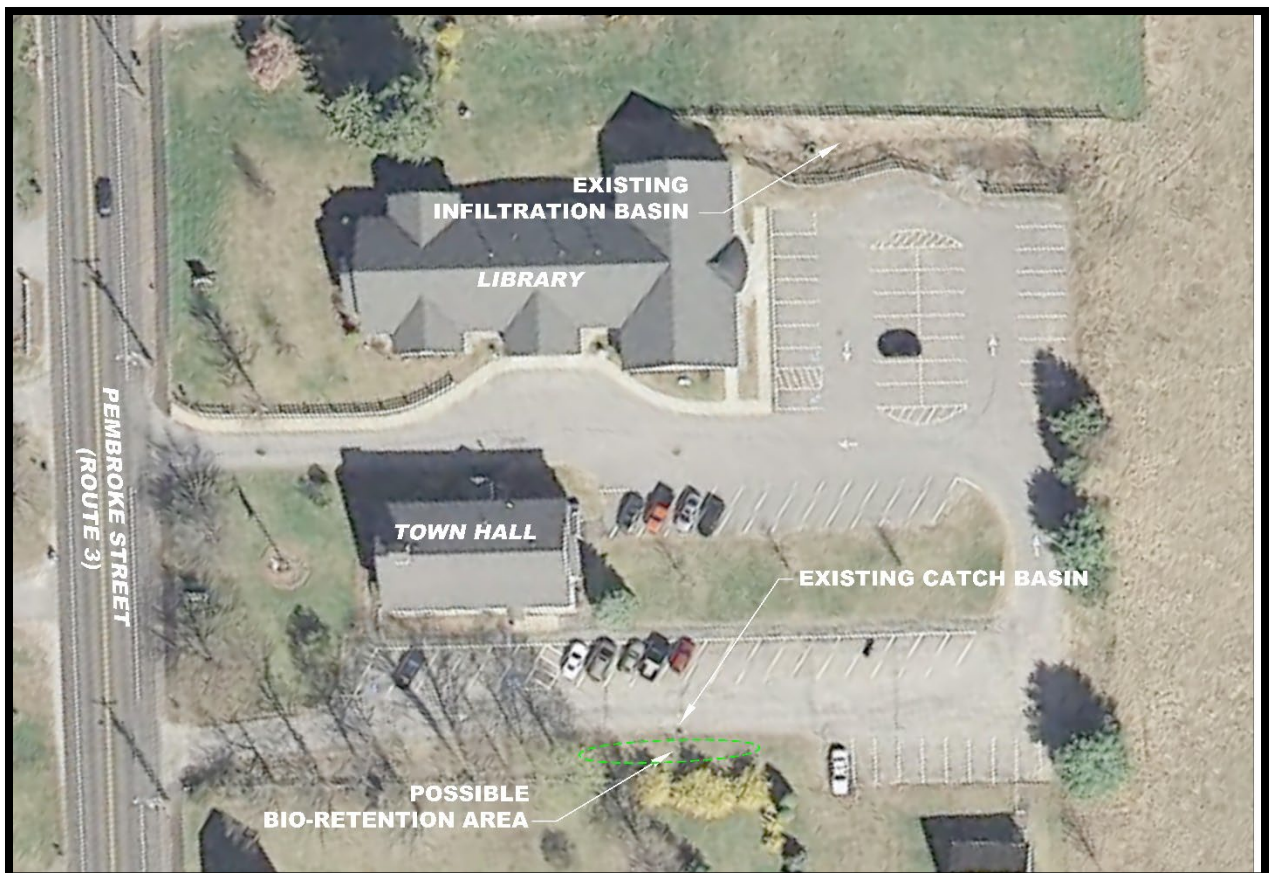
## Town Hall and Library (PRIORITY #2)

The two buildings share a common parking area that has two discharge points. The Library parking lot primarily flows into an infiltration basin that has an overflow connected to the State drainage system on Pembroke Street (Route 3). The southern portion of the parking lot (near Town Hall) drains directly to Pembroke Street (Route 3). The infiltration basin appears to be functioning properly.

The library parking area should continue to drain to the infiltration basin and no improvements are recommended. The parking lot associated with the Town Hall is scheduled to be reconstructed in the next few years and there is some available space to install water quality BMP. It is recommended that a bio-retention area (rain garden) or some tree box filters be considered as part of the parking lot reconstruction (see figure below).

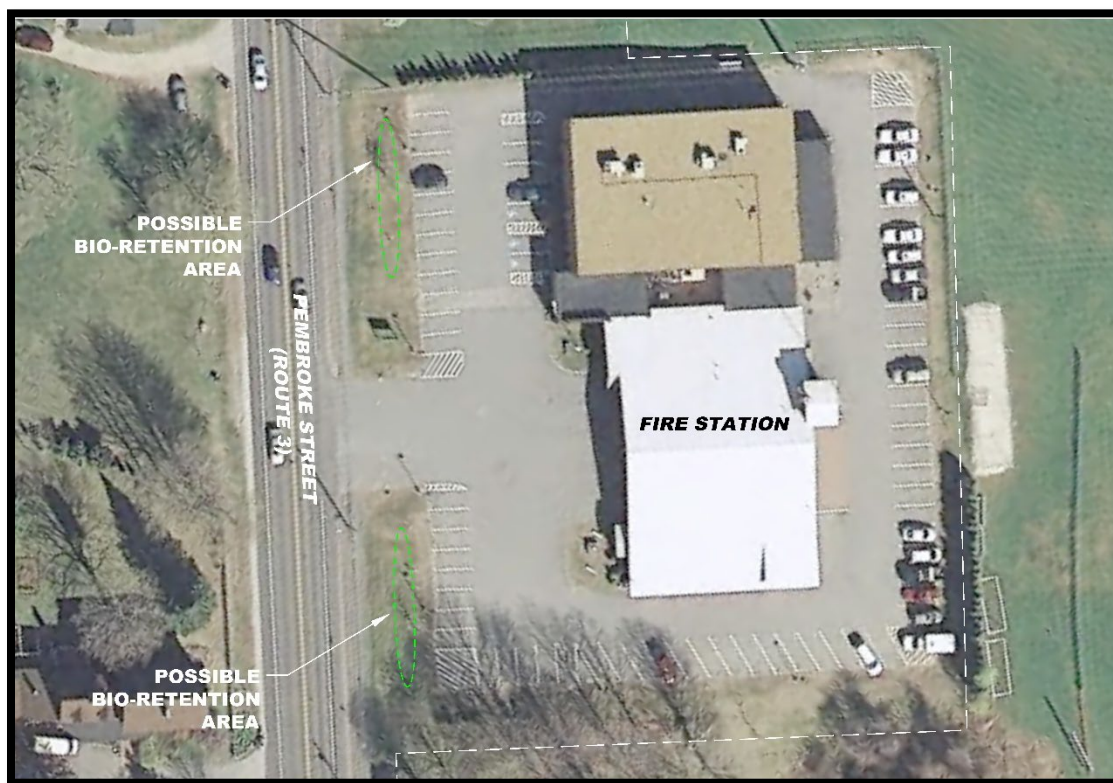
## Fire Station (PRIORITY #3)

The parking lot in the front of the building flows into a grass swale and then into the State drainage system on Pembroke Street (Route 3). Drainage from the back parking lot flows through a pipe to the front of the building, into the site drainage system, and then into the State drainage system. A few years ago, a stone infiltration system to collect roof runoff was installed on the south end of the building as a safety measure to prevent snow/ice falling from the roof onto pedestrians (not shown on the figure).

The lawn areas between the fire station parking area and Pembroke Street (Route 3) could be reconstructed to collect parking lot runoff and treat it prior to release into the drainage system. It is recommended that infiltration basins, bio-retention areas (rain gardens), or some tree box filters be considered at this location (see figure below).

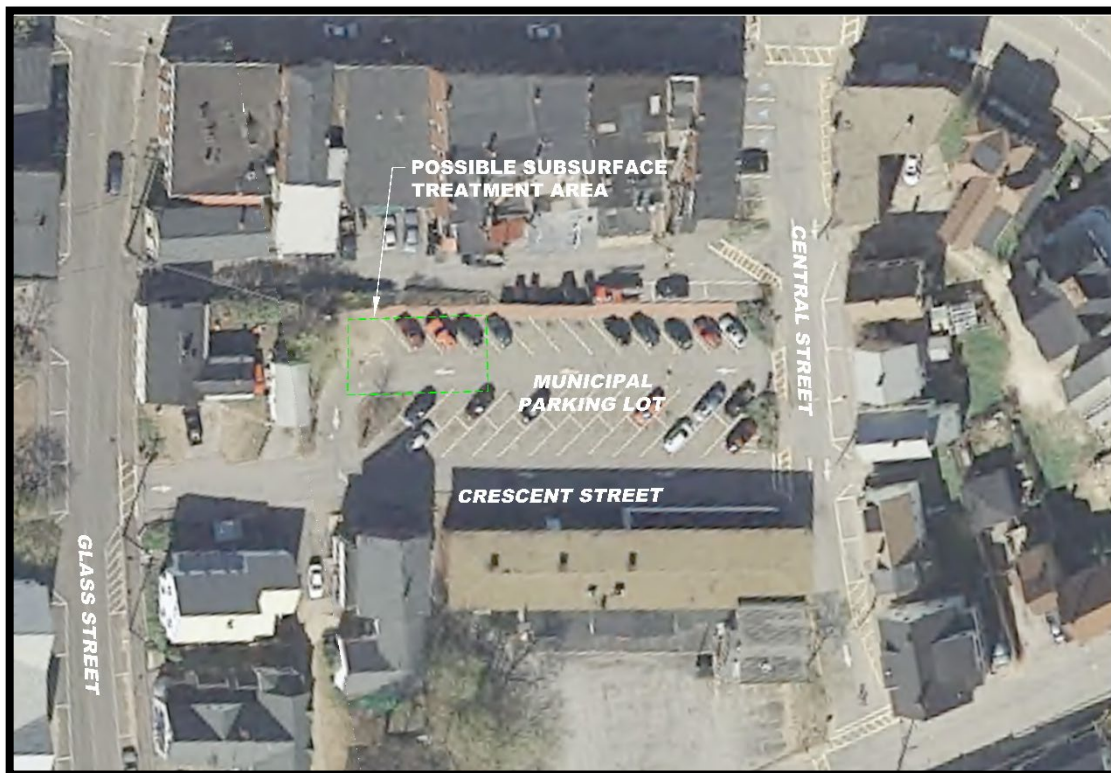
## Central Street Parking Lot (PRIORITY #4)

The parking lot is located adjacent to Crescent Street and extends from Central Street to Glass Street. Drainage runoff from the site flows towards Glass Street and is collected by catch basins that tie into the Glass Street drainage system.

There is a possibility of constructing a water quality BMP beneath the pavement but subsurface geotechnical data would be required to determine this feasibility. Future efforts could include investigation into possible subsurface system construction; however, system installation will be very costly.
