## TOWN OF ALLENSTOWN OUTFALL SUMMARY REPORT

### ALLENSTOWN MS4 AREA Allenstown, New Hampshire

August 22, 2023

File No. 09.0026194.00 REV1

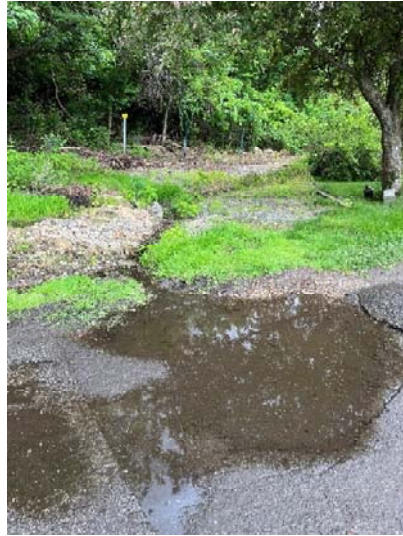
**Description:**  
OF-5 on June 8, 2023

No pipe outlet located. Catch basin removed. No longer an outfall. Photo is taken at the location of the removed catch basin.

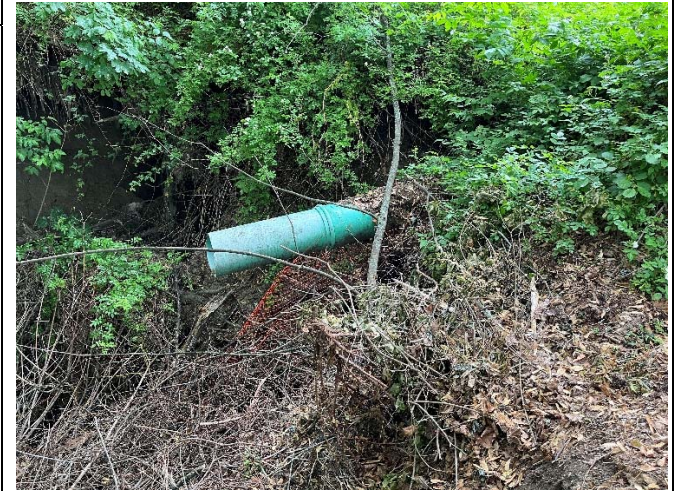
**Photo 6**

**Description:**  
OF-6 on June 8, 2023

Catch basin removed, pipe abandoned in place. No longer an outfall. Photo of abandoned pipe outlet.

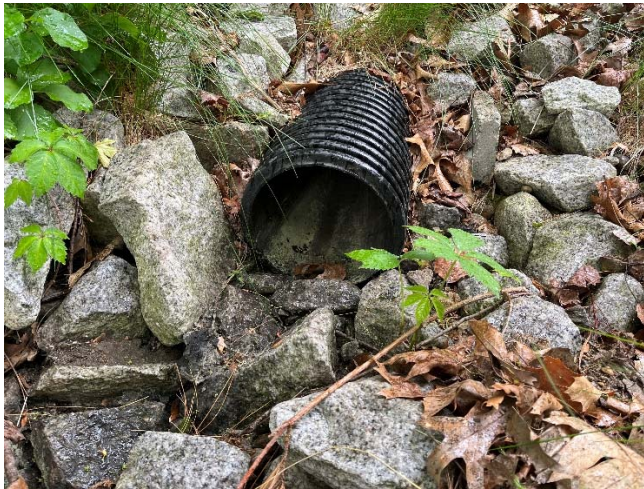
**Photo 7**

**Description:**  
OF-7 on June 8, 2023

No active flow observed.

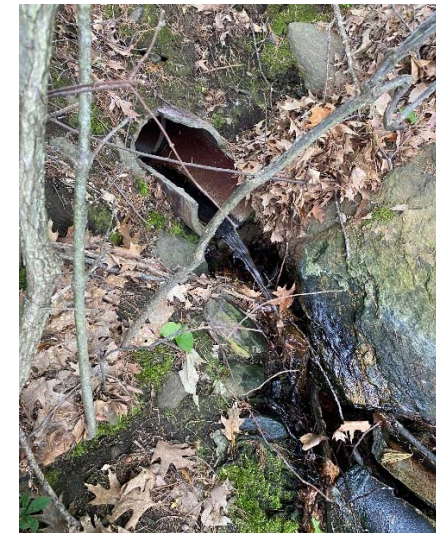
**Photo 8**

**Description:**  
OF-8 on June 8, 2023

Pipe is broken. Active flow observed. Sample collected.

Photographs of each outfall locations with specific maintenance notes can be found in **Appendix C**. Maintenance is recommended at eleven (11) outfalls: OF-2 (fully submerged), OF-8 (broken pipe), OF-10 (partially submerged), OF-11 (partially filled with leaves), OF-13 (broken pipe), OF-15 (partially submerged), OF-16 (covered with rip rap), OF-17 (partially submerged), OF-20 (partially filled with soil/sediment), OF-21 (partially filled with leaves), and OF-27 (broken head wall).

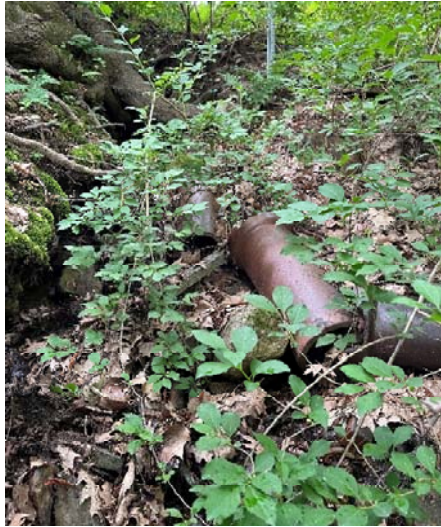
<b>Photo 13</b>  <b>Description:</b> OF-13 on June 8, 2023  No active flow observed. Outfall pipe is broken.

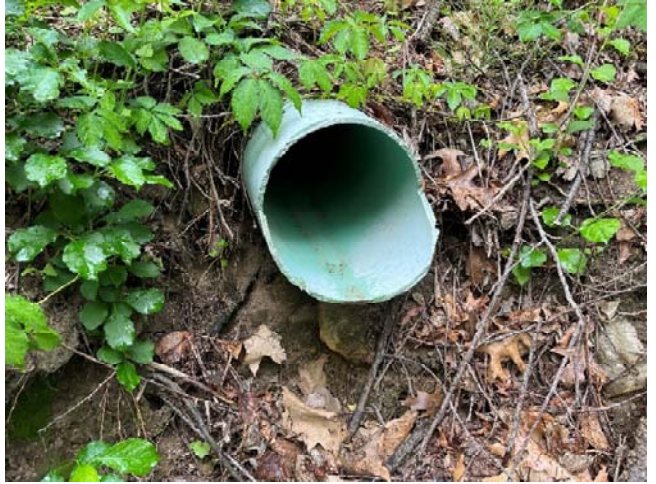
<b>Photo 14</b>  <b>Description:</b> OF-14 on June 8, 2023  No active flow observed.

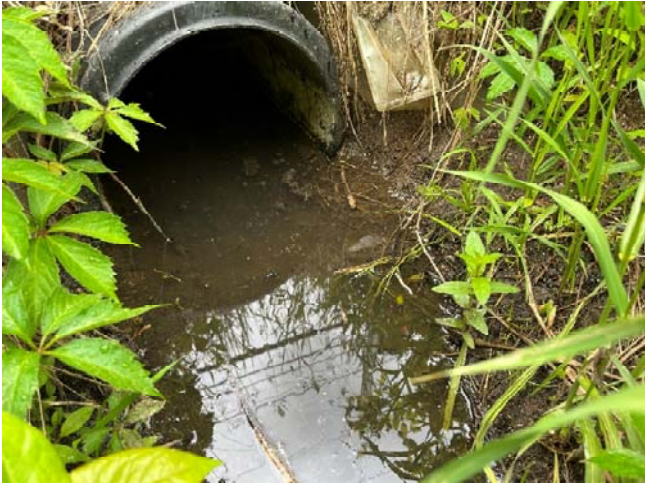
<b>Photo 15</b>  <b>Description:</b> OF-15 on June 8, 2023  Outfall partially submerged. Upstream catch basin not flowing.

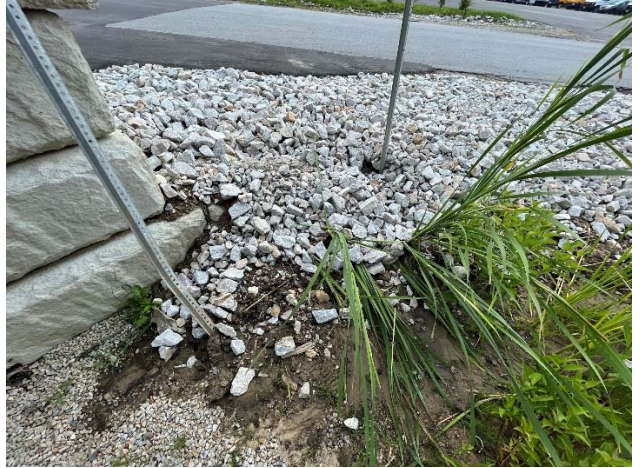
<b>Photo 16</b>  <b>Description:</b> OF-16 on June 12, 2023  No active flow observed. Pipe outlet is covered with rip rap.

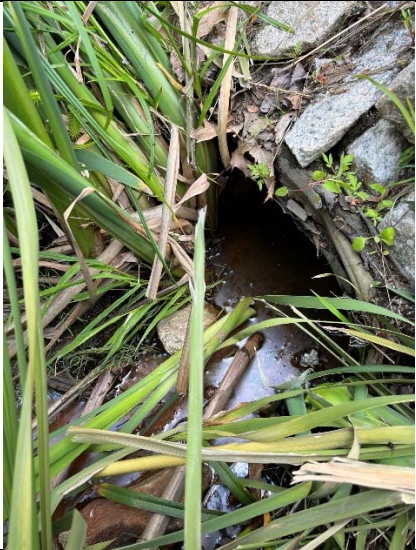
<b>Photo 17</b>  <b>Description:</b> OF-17 on June 12, 2023  No active flow observed. Outfall partially submerged.

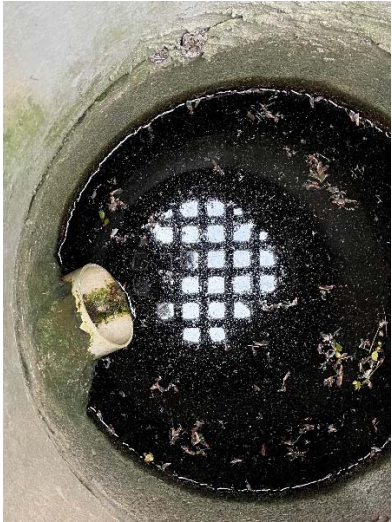
<b>Photo 18</b>  <b>Description:</b> OF-18 on June 8, 2023  No outfall pipe outlet observed. No active flow in upstream catch basin shown in photo.

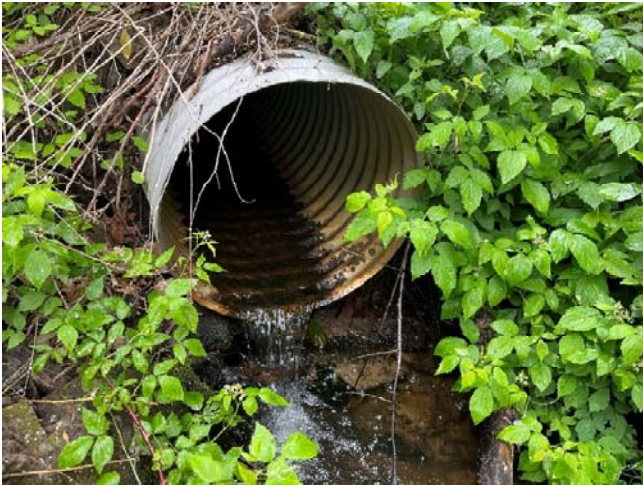
<b>Photo 19</b>  <b>Description:</b> OF-19 on June 8, 2023  Active flow observed. Sample collected.

GZA recommends the Town update the priority ranking of outfalls and interconnections in its Illicit Discharge Detection and Elimination (IDDE) plan along with updating its GIS mapping to reflect the findings outlined in this report. GZA recommends source tracing and investigation for OF-19, which should be categorized as a problem outfall pending investigation.

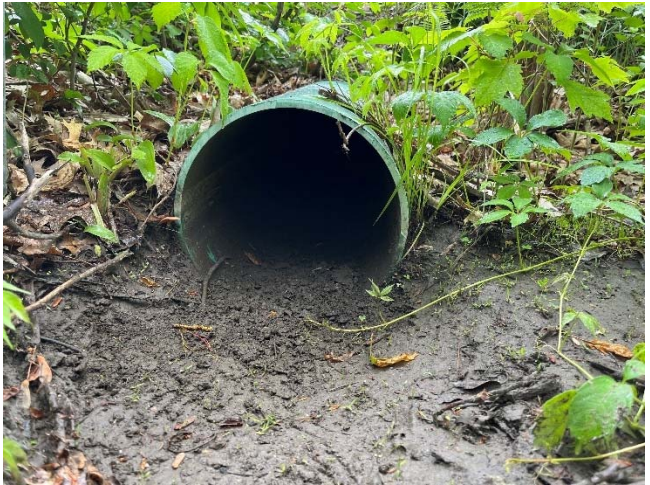
<b>Photo 20</b>  <b>Description:</b> OF-20 on June 8, 2023  No active flow observed. Outfall pipe partially filled with soil/sediment.

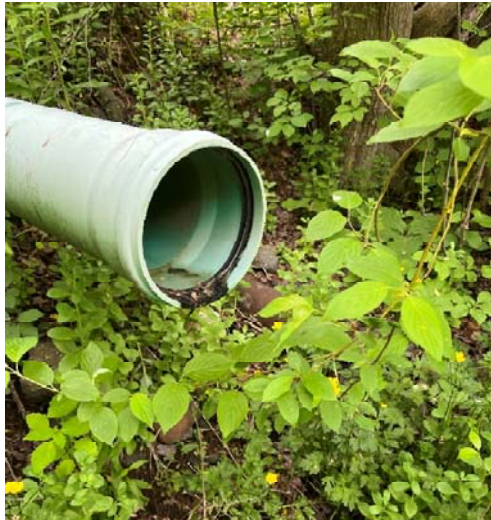
**Description:**  
OF-25 on June 8, 2023

Outfall to be included in next MS4 permit. No active flow observed.

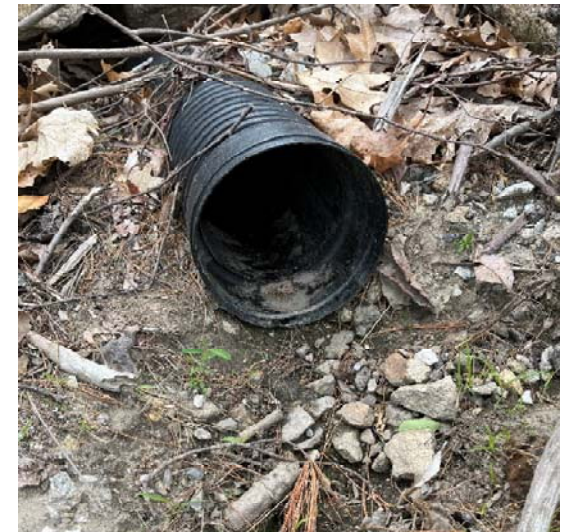
**Photo 26**

**Description:**  
OF-26 on June 8, 2023

Outfall to be included in next MS4 permit. No active flow observed.

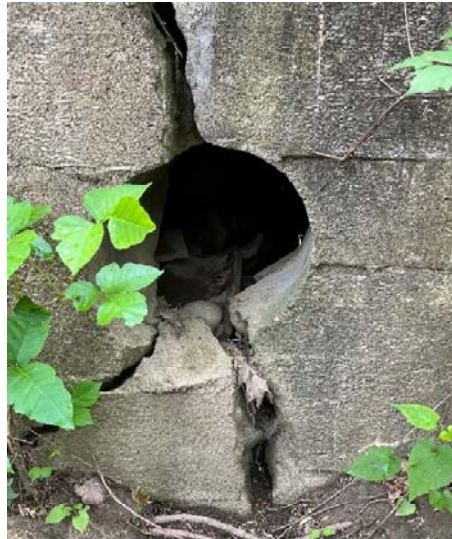
**Photo 27**

**Description:**  
OF-27 on June 8, 2023

Outfall to be included in next MS4 permit. Pipe outlet located in broken head wall. No active flow observed.

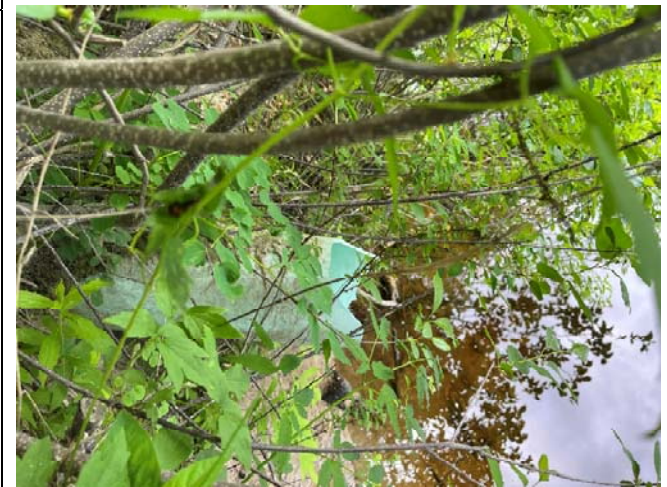
**Photo 28**

**Description:**  
OF-28 on June 8, 2023

Outfall to be included in next MS4 permit. No active flow observed.
